4. TITLE AND SUBTITLE
The Use of Electrochemistry and Ellipsometry for Identifying and Evaluating Corrosion on Aircraft.

DACCO SCI, INC.
10260 Old Columbia Road
Columbia, MD 21046

**THE USE OF ELECTROCHEMISTRY
AND ELLIPSOMETRY FOR IDENTIFYING AND EVALUATING
CORROSION ON AIRCRAFT**

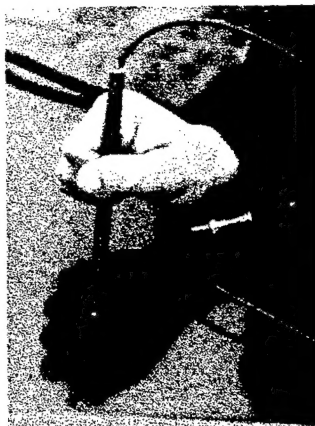
Figure 3. *Hand held in-situ corrosion sensor.*

Two versions of the *in-situ* sensor have been developed: a permanently attached sensor and a portable hand-held sensor. The former is suitable for corrosion inspection in inaccessible areas or for automatic or semi-automatic inspection of a particular area. A laboratory test specimen with an attached sensor is shown in Figure 2. The hand-held sensor is suitable for spot inspection where a permanent sensor is not desired or had not been previously placed. Figure 3 shows a prototype in use.

The final prototype sensor (Figure 3) was designed to provide easier use than the upscale sensor. It had a much smaller diameter and was several inches longer. A long shielded lead wire was permanently attached. This allowed the connection to the Gamry to be made at a distance from the sensor, thus eliminating the wire congestion around the sensor. The connection to the Gamry was made with a BNC connector. The sensor was intended to be used like a pen-type probe. The final sensor was much easier to use and provided results similar to both the first prototype sensor and the upscale sensor (Figure 27).

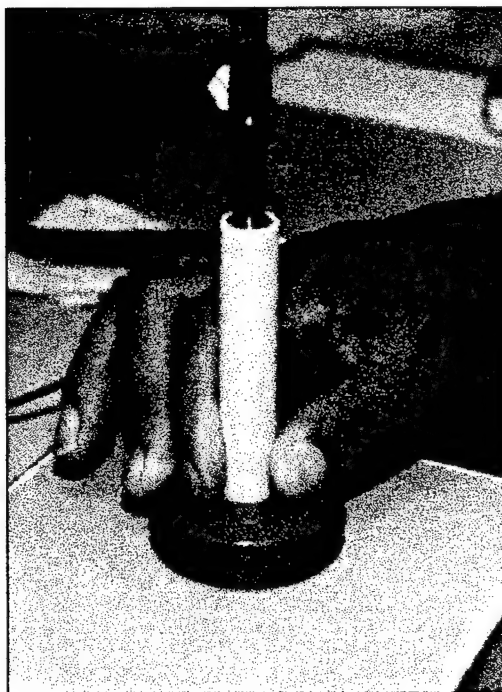
Figure 25. *Upscale Prototype Sensor.*

The upscale prototype hand-held sensor was fabricated with the sensing component encased in a PVC shell (Figure 25). The circular base of the sensor was also constructed of PVC and was sized to allow the sensor to be held by the fingertips or in a manner similar to a joystick.

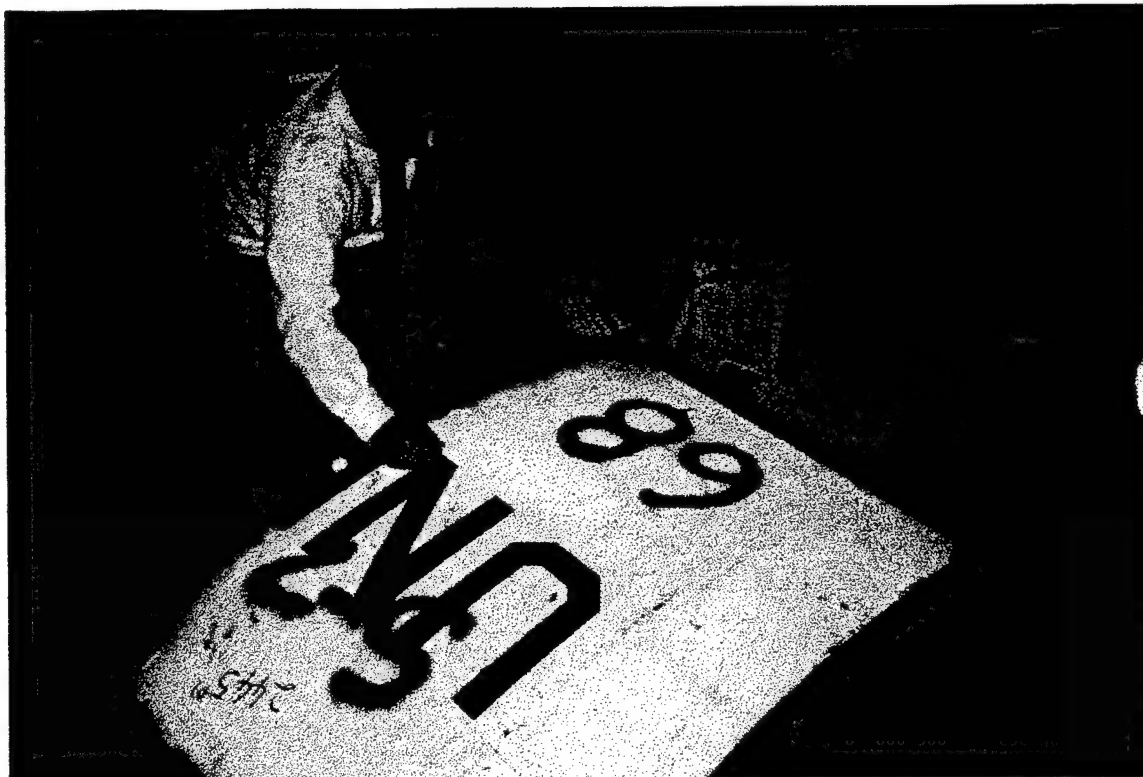
Figure 31. *Photograph of Testing on C130 Fuselage.*

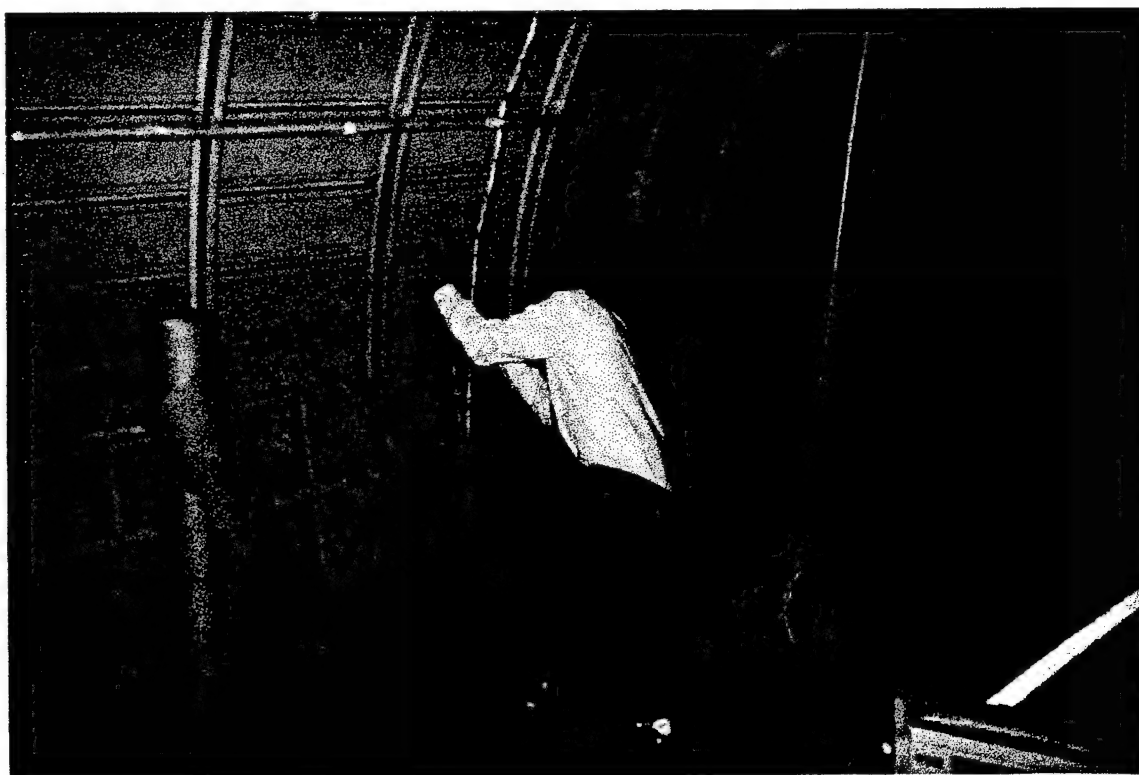
Figure 32. *Photograph of Testing on C-135.*

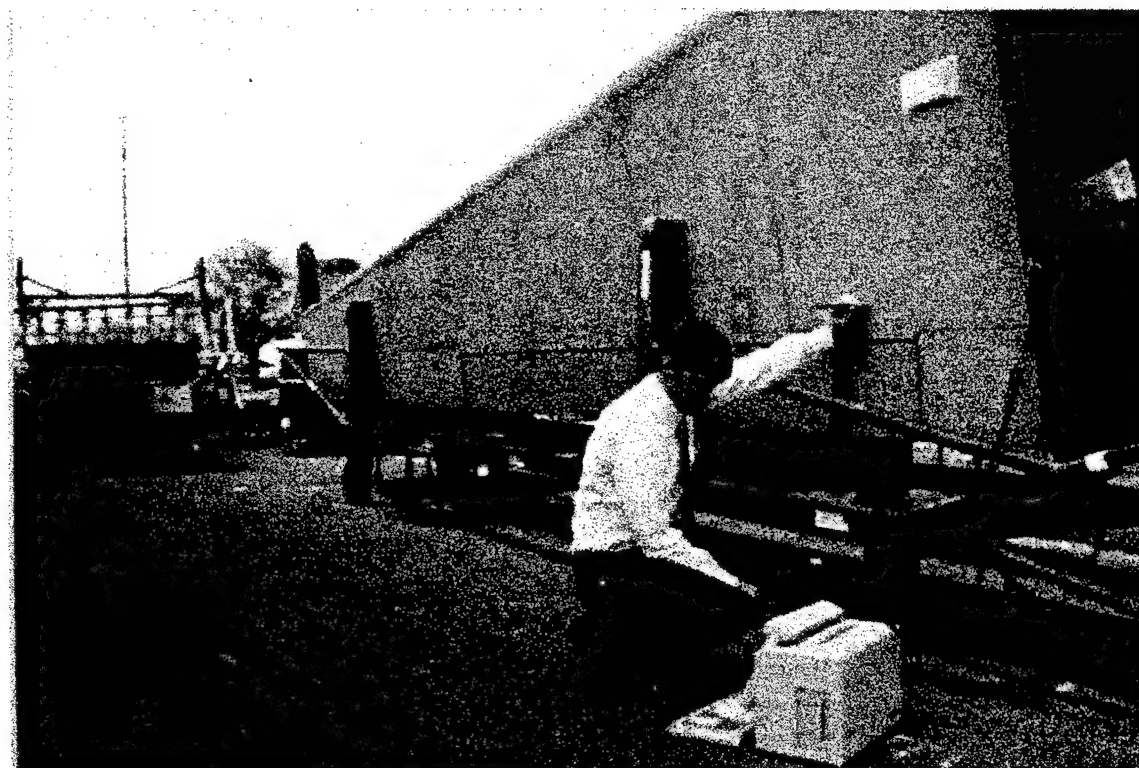
Figure 34. *Photograph of Testing on C130 Elevator Rudder.*
